# Former Buckley & Mann

June 6, 2018

# Presentation Outline

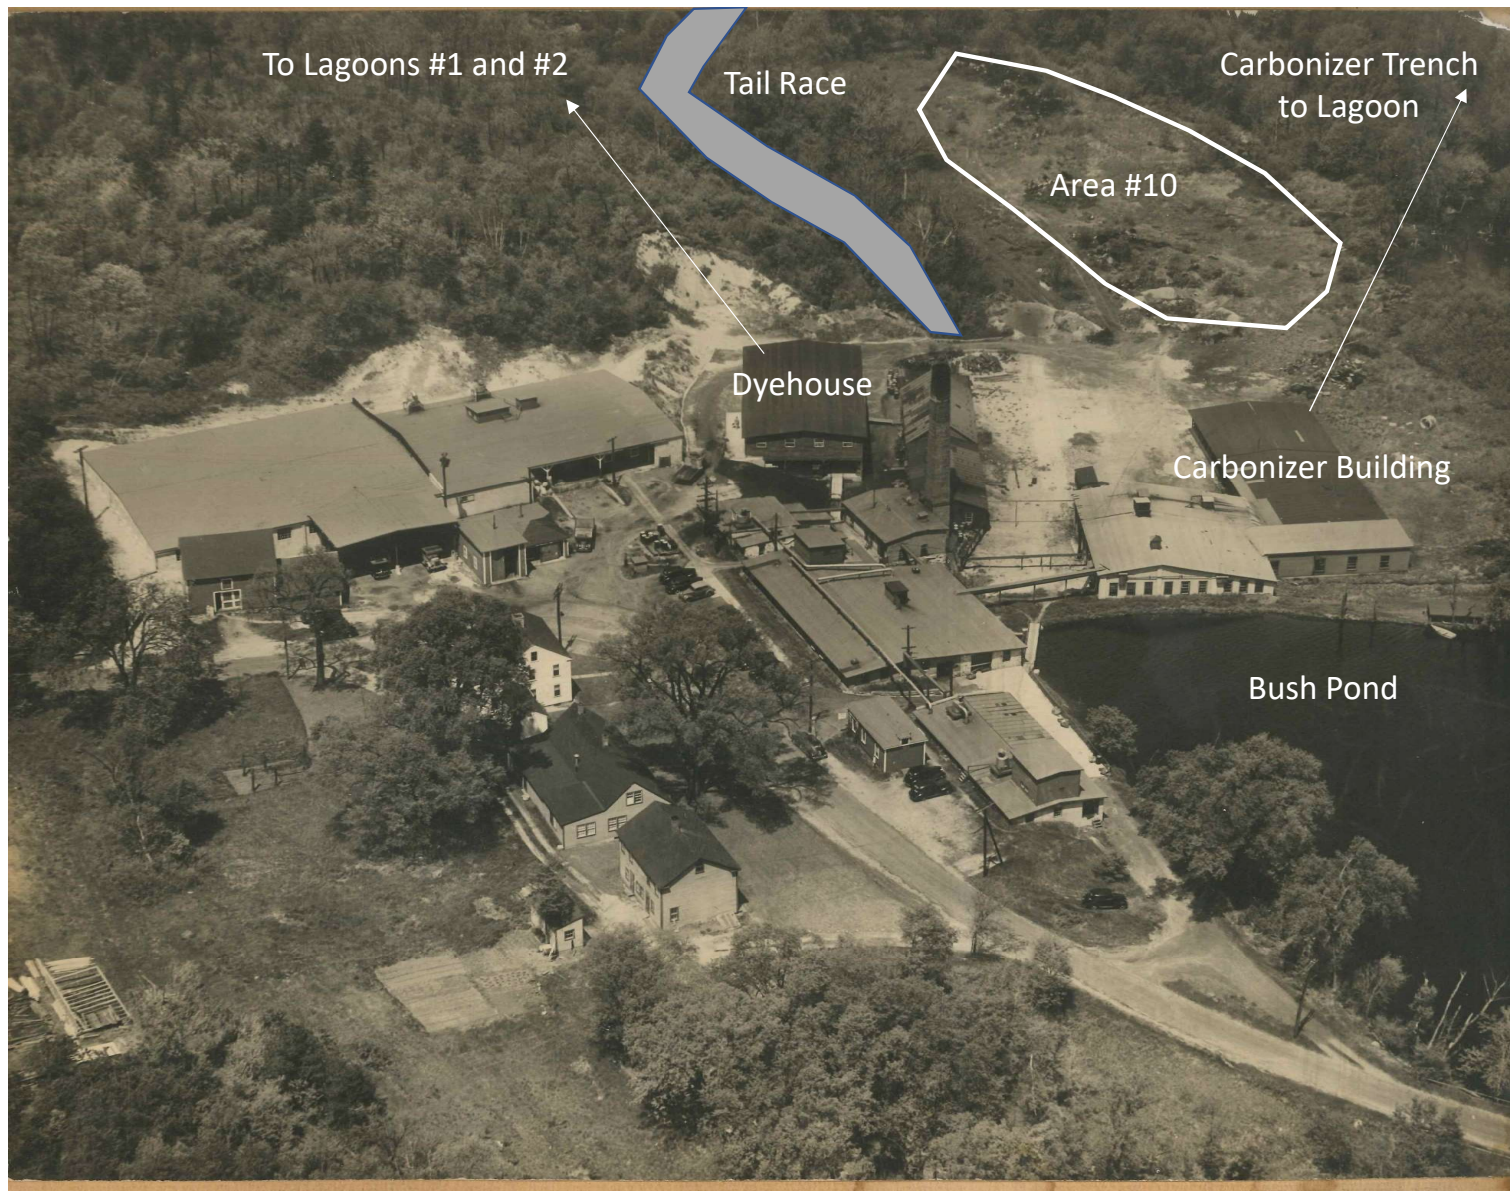
# 1995 Site Plan

The map illustrates the 1995 site plan, highlighting various environmental and regulatory features. Key elements include:

- Geographical Features:** Mill River, Carbonizer Lagoon, Wetland, Bush Pond, and several lagoons (Lagoon #1, Lagoon #2).
- Infrastructure:** Lawrence Street, Access to Lawrence St., and various building footprints.

- Sampling Locations:** Numerous test pits (TP-01 to TP-28) and sample locations (e.g., 1996 SS-S, SS-SA) are marked throughout the site.
- Legend:**
  - Solid line: LIMIT OF SOURCE AREA FILES

- 1. LAGOON #1 BOTTOM SOILS
  - 2. LAGOON #2 BOTTOM SOILS
  - 3. LAGOON #1 SOILS EXCAVATED PRIOR TO 1975
  - 4. DRYLAND MATERIAL SCRAPED FROM LAGOON #1 IN 1988

- 5. SOILS SCRAPED FROM LAGOON #1 IN 1986, STOCKPILED SOUTHWEST OF LAGOON #1
  - 6. SOILS EXCAVATED FROM THE FORMER DYEHOUSE TRENCH TO LAGOON #1
  - 7. DRYLAND MATERIAL COLLECTED IN 1986 FROM A SMALL PIT WHERE WOODEN DRUM(S) WITH DYE PASTE WAS BURIED

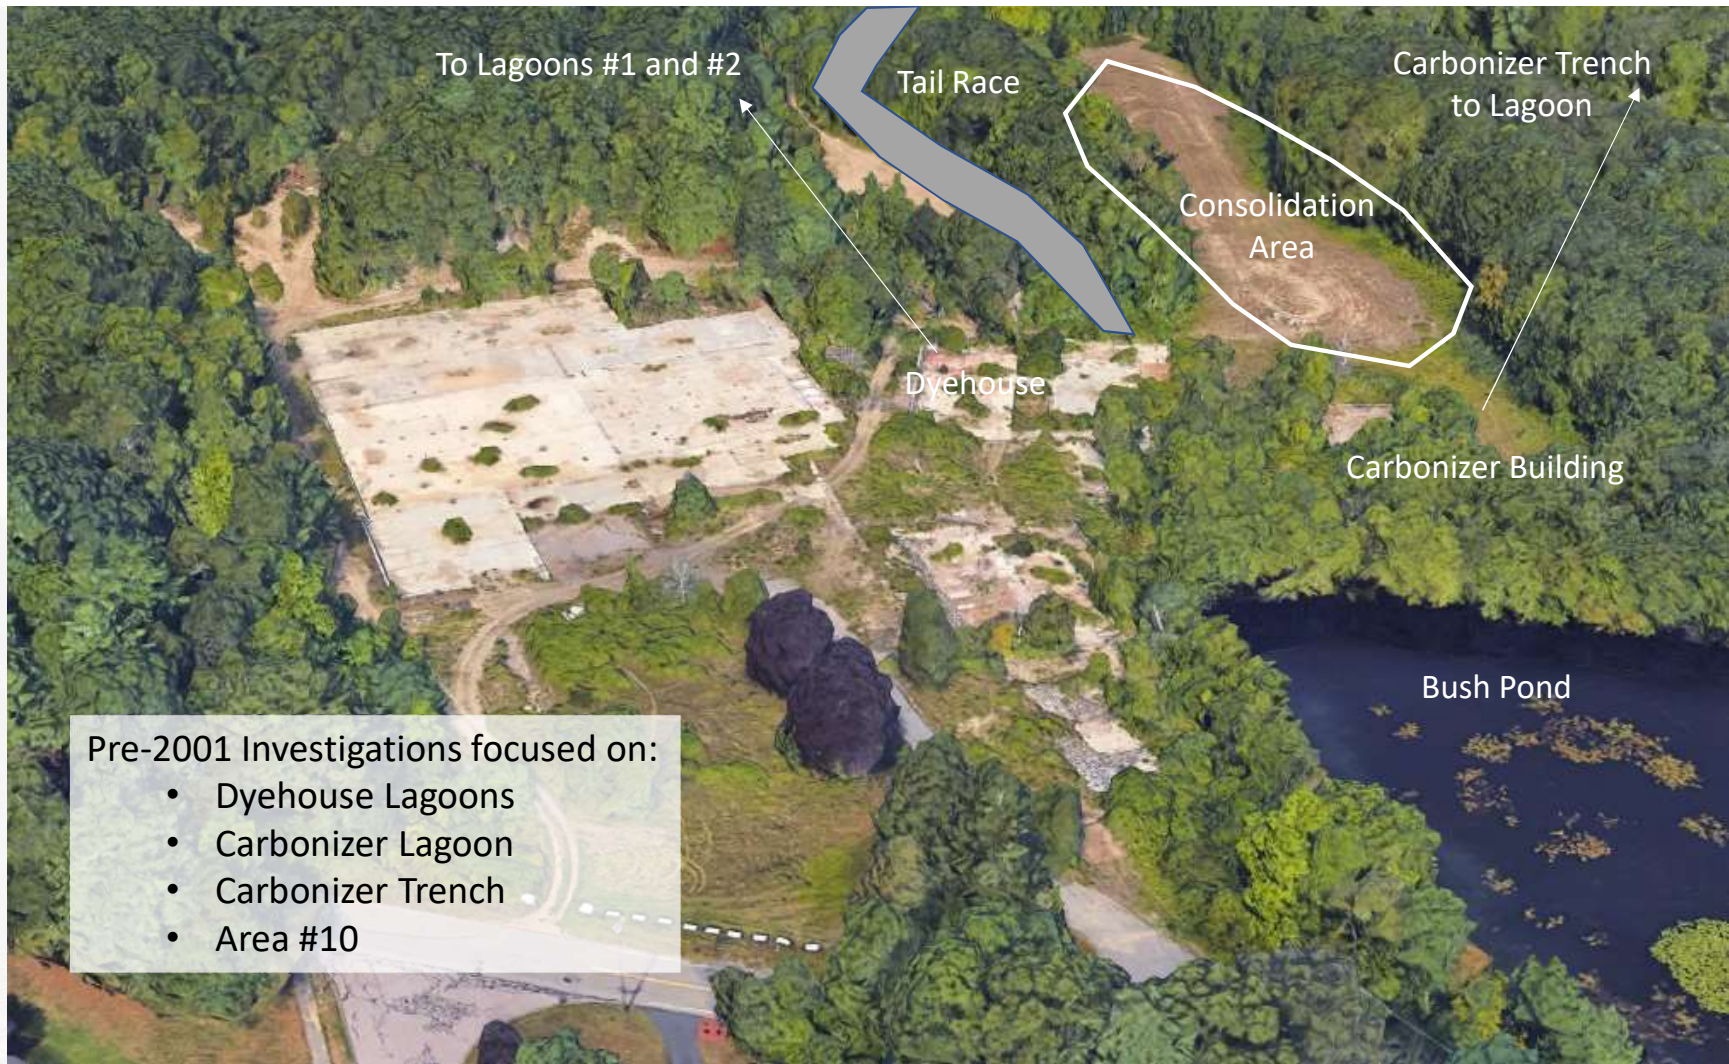
- 8. PIT FROM WHICH WOODEN DRUM(S) WITH DYE PASTE WAS EXCAVATED IN 1986
  - 9. CARBONIZER LAGOON
  - 10. CARBONIZER SPOILS AND BUILDING DEMOLITION DEBRIS

- 11. TRENCH TO CARBONIZER LAGOON
  - 12. FIRE PIT
  - 13. GROUNDWATER (NOT SHOWN)
  - 14. SOILS IN BUILDING COMPLEX
- Scale:** 0 to 100 FEET

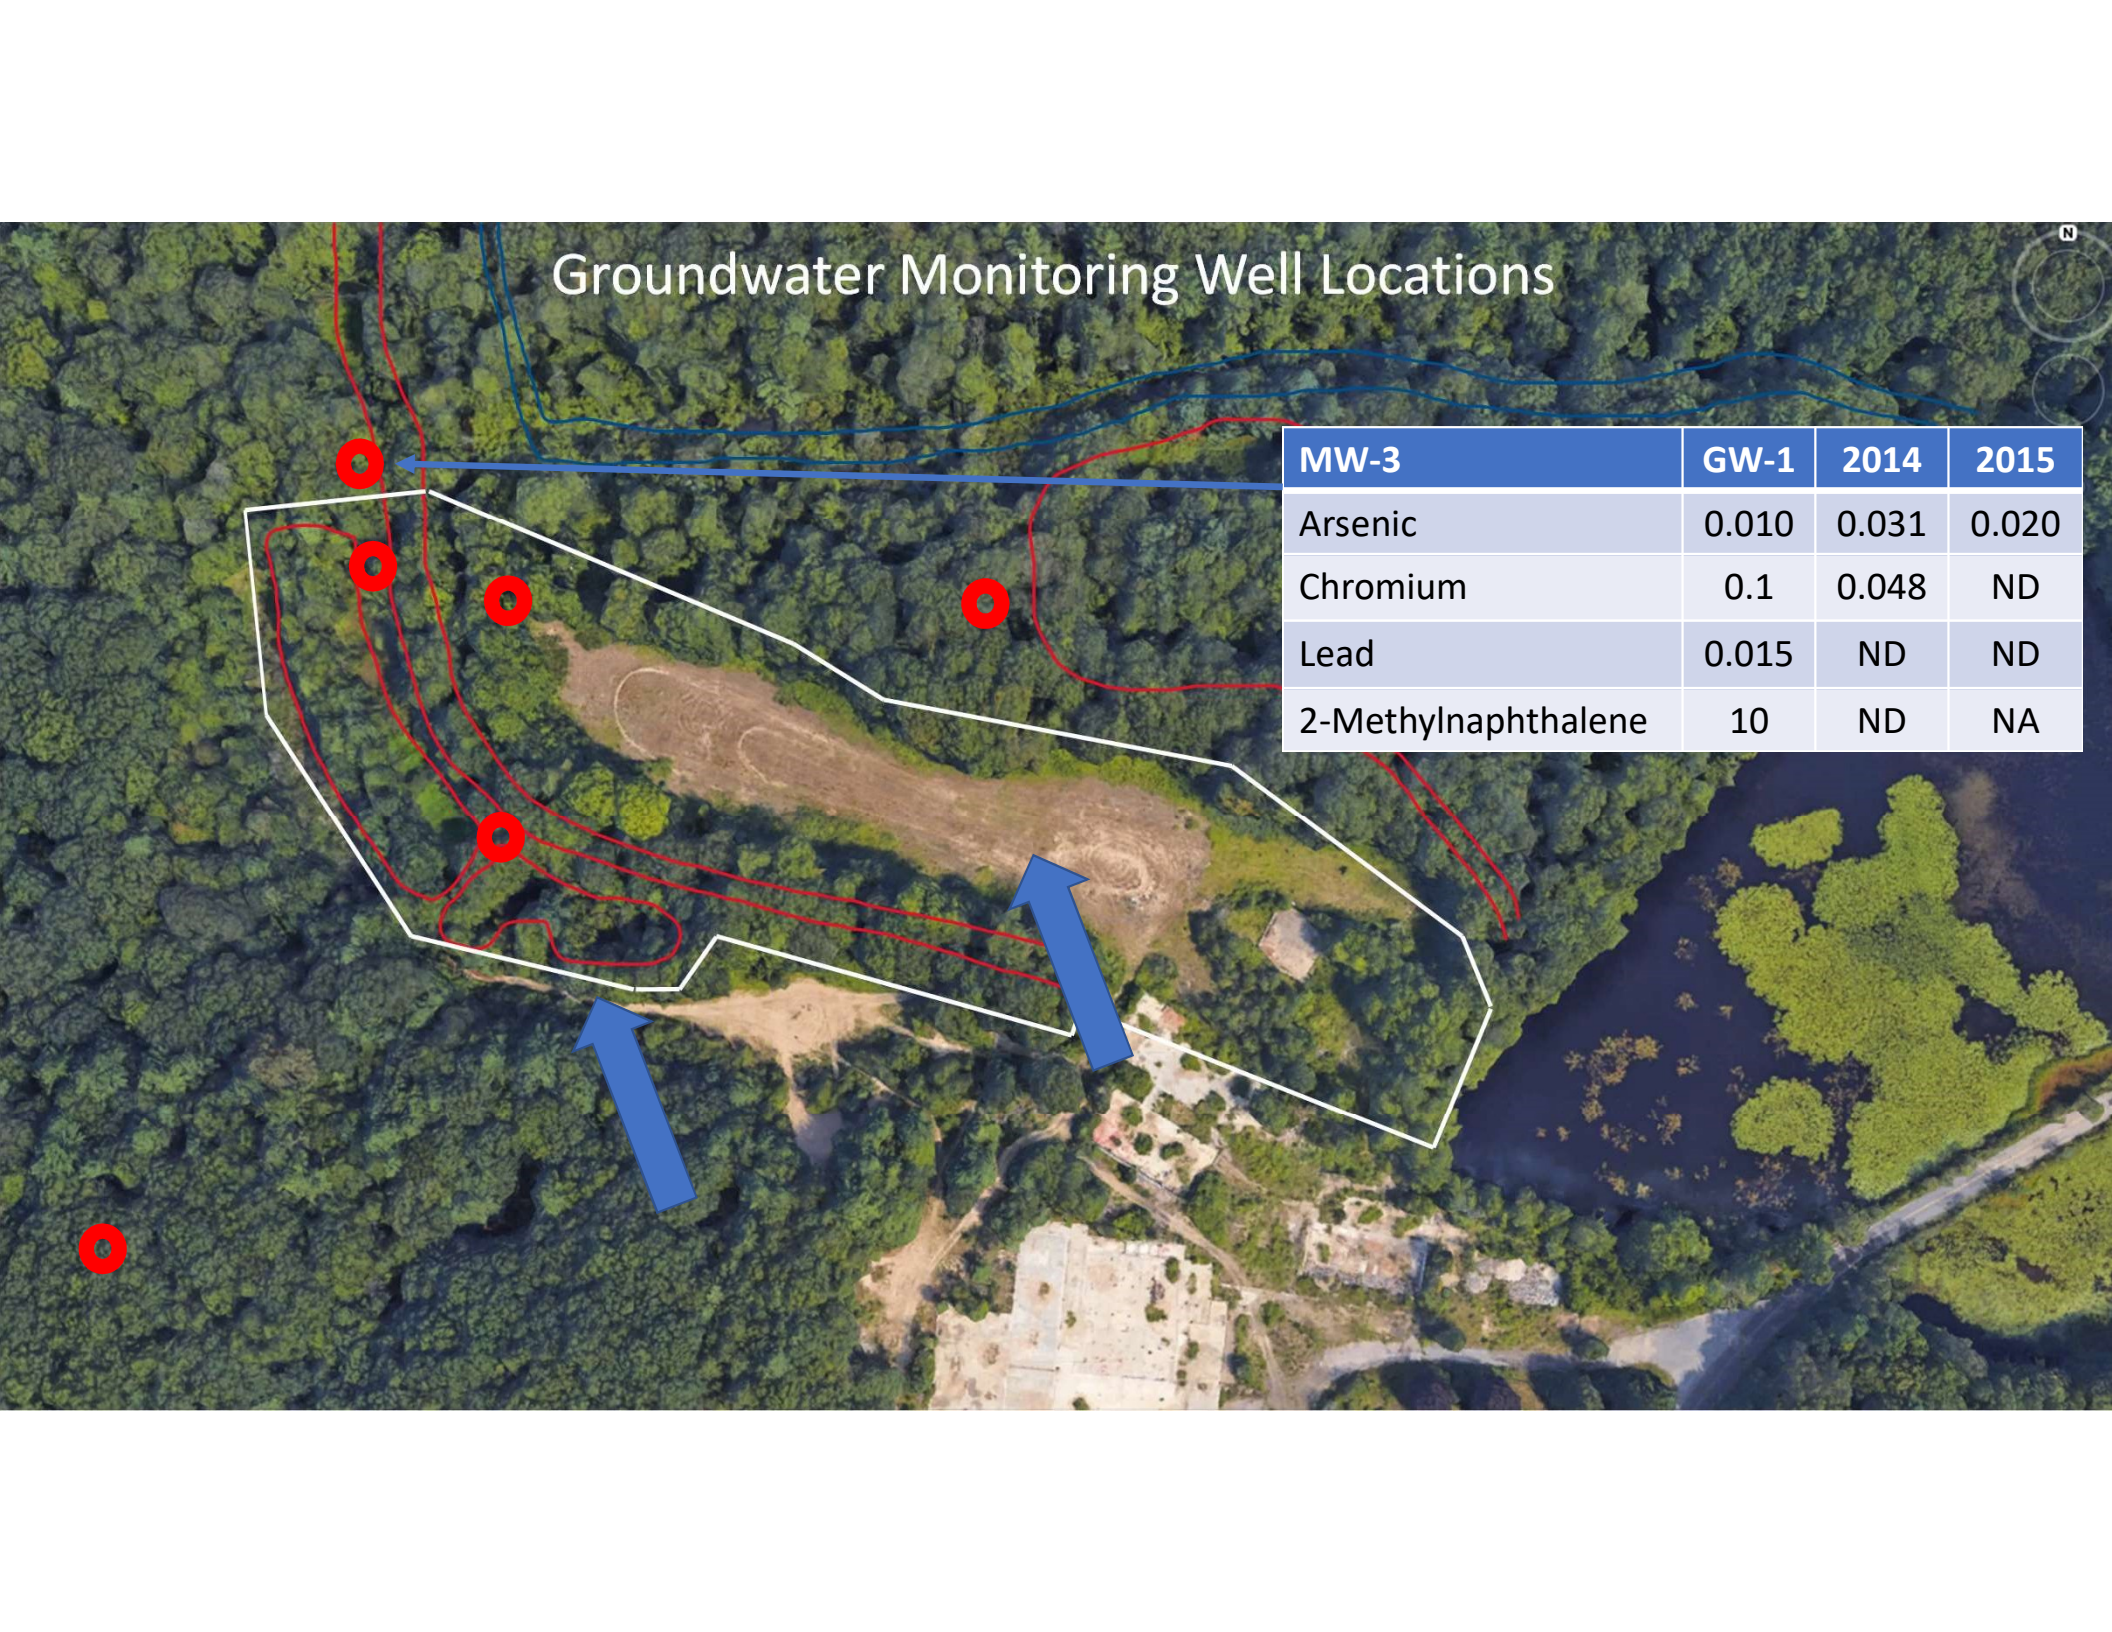
## Groundwater Monitoring Well Locations

MW-3	GW-1	2014	2015
Arsenic	0.010	0.031	0.020
Chromium	0.1	0.048	ND
Lead	0.015	ND	ND
2-Methylnaphthalene	10	ND	NA

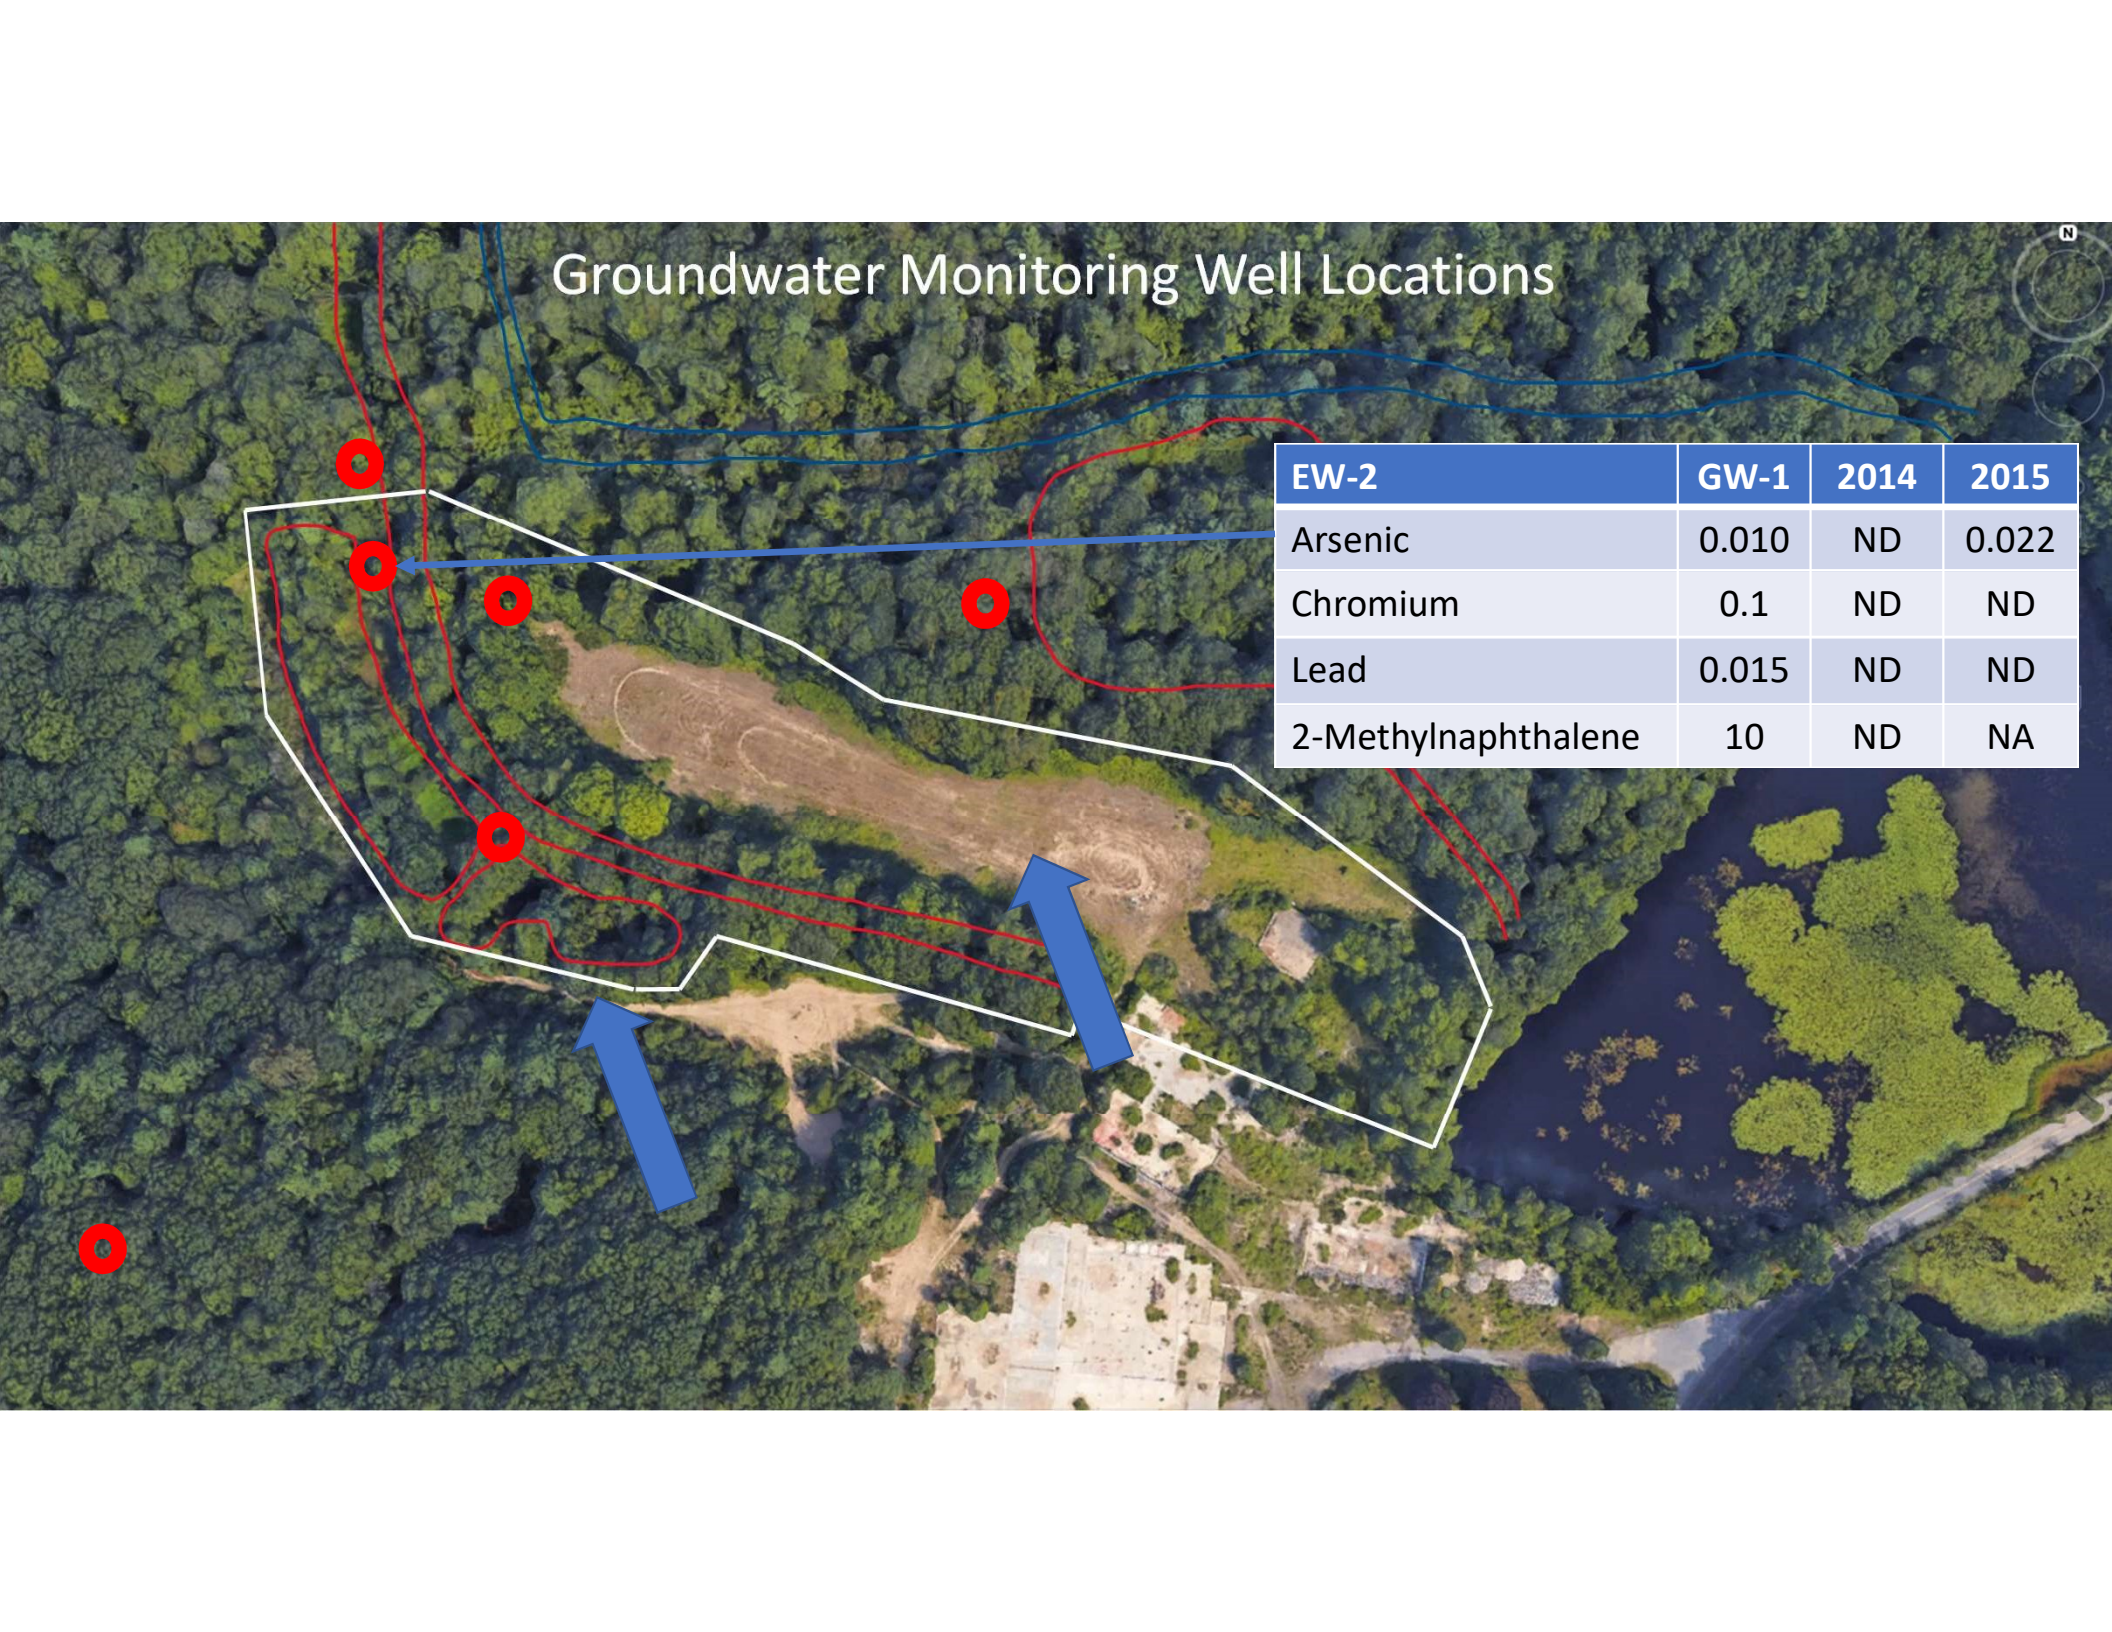
## Groundwater Monitoring Well Locations

EW-2	GW-1	2014	2015
Arsenic	0.010	ND	0.022
Chromium	0.1	ND	ND
Lead	0.015	ND	ND
2-Methylnaphthalene	10	ND	NA

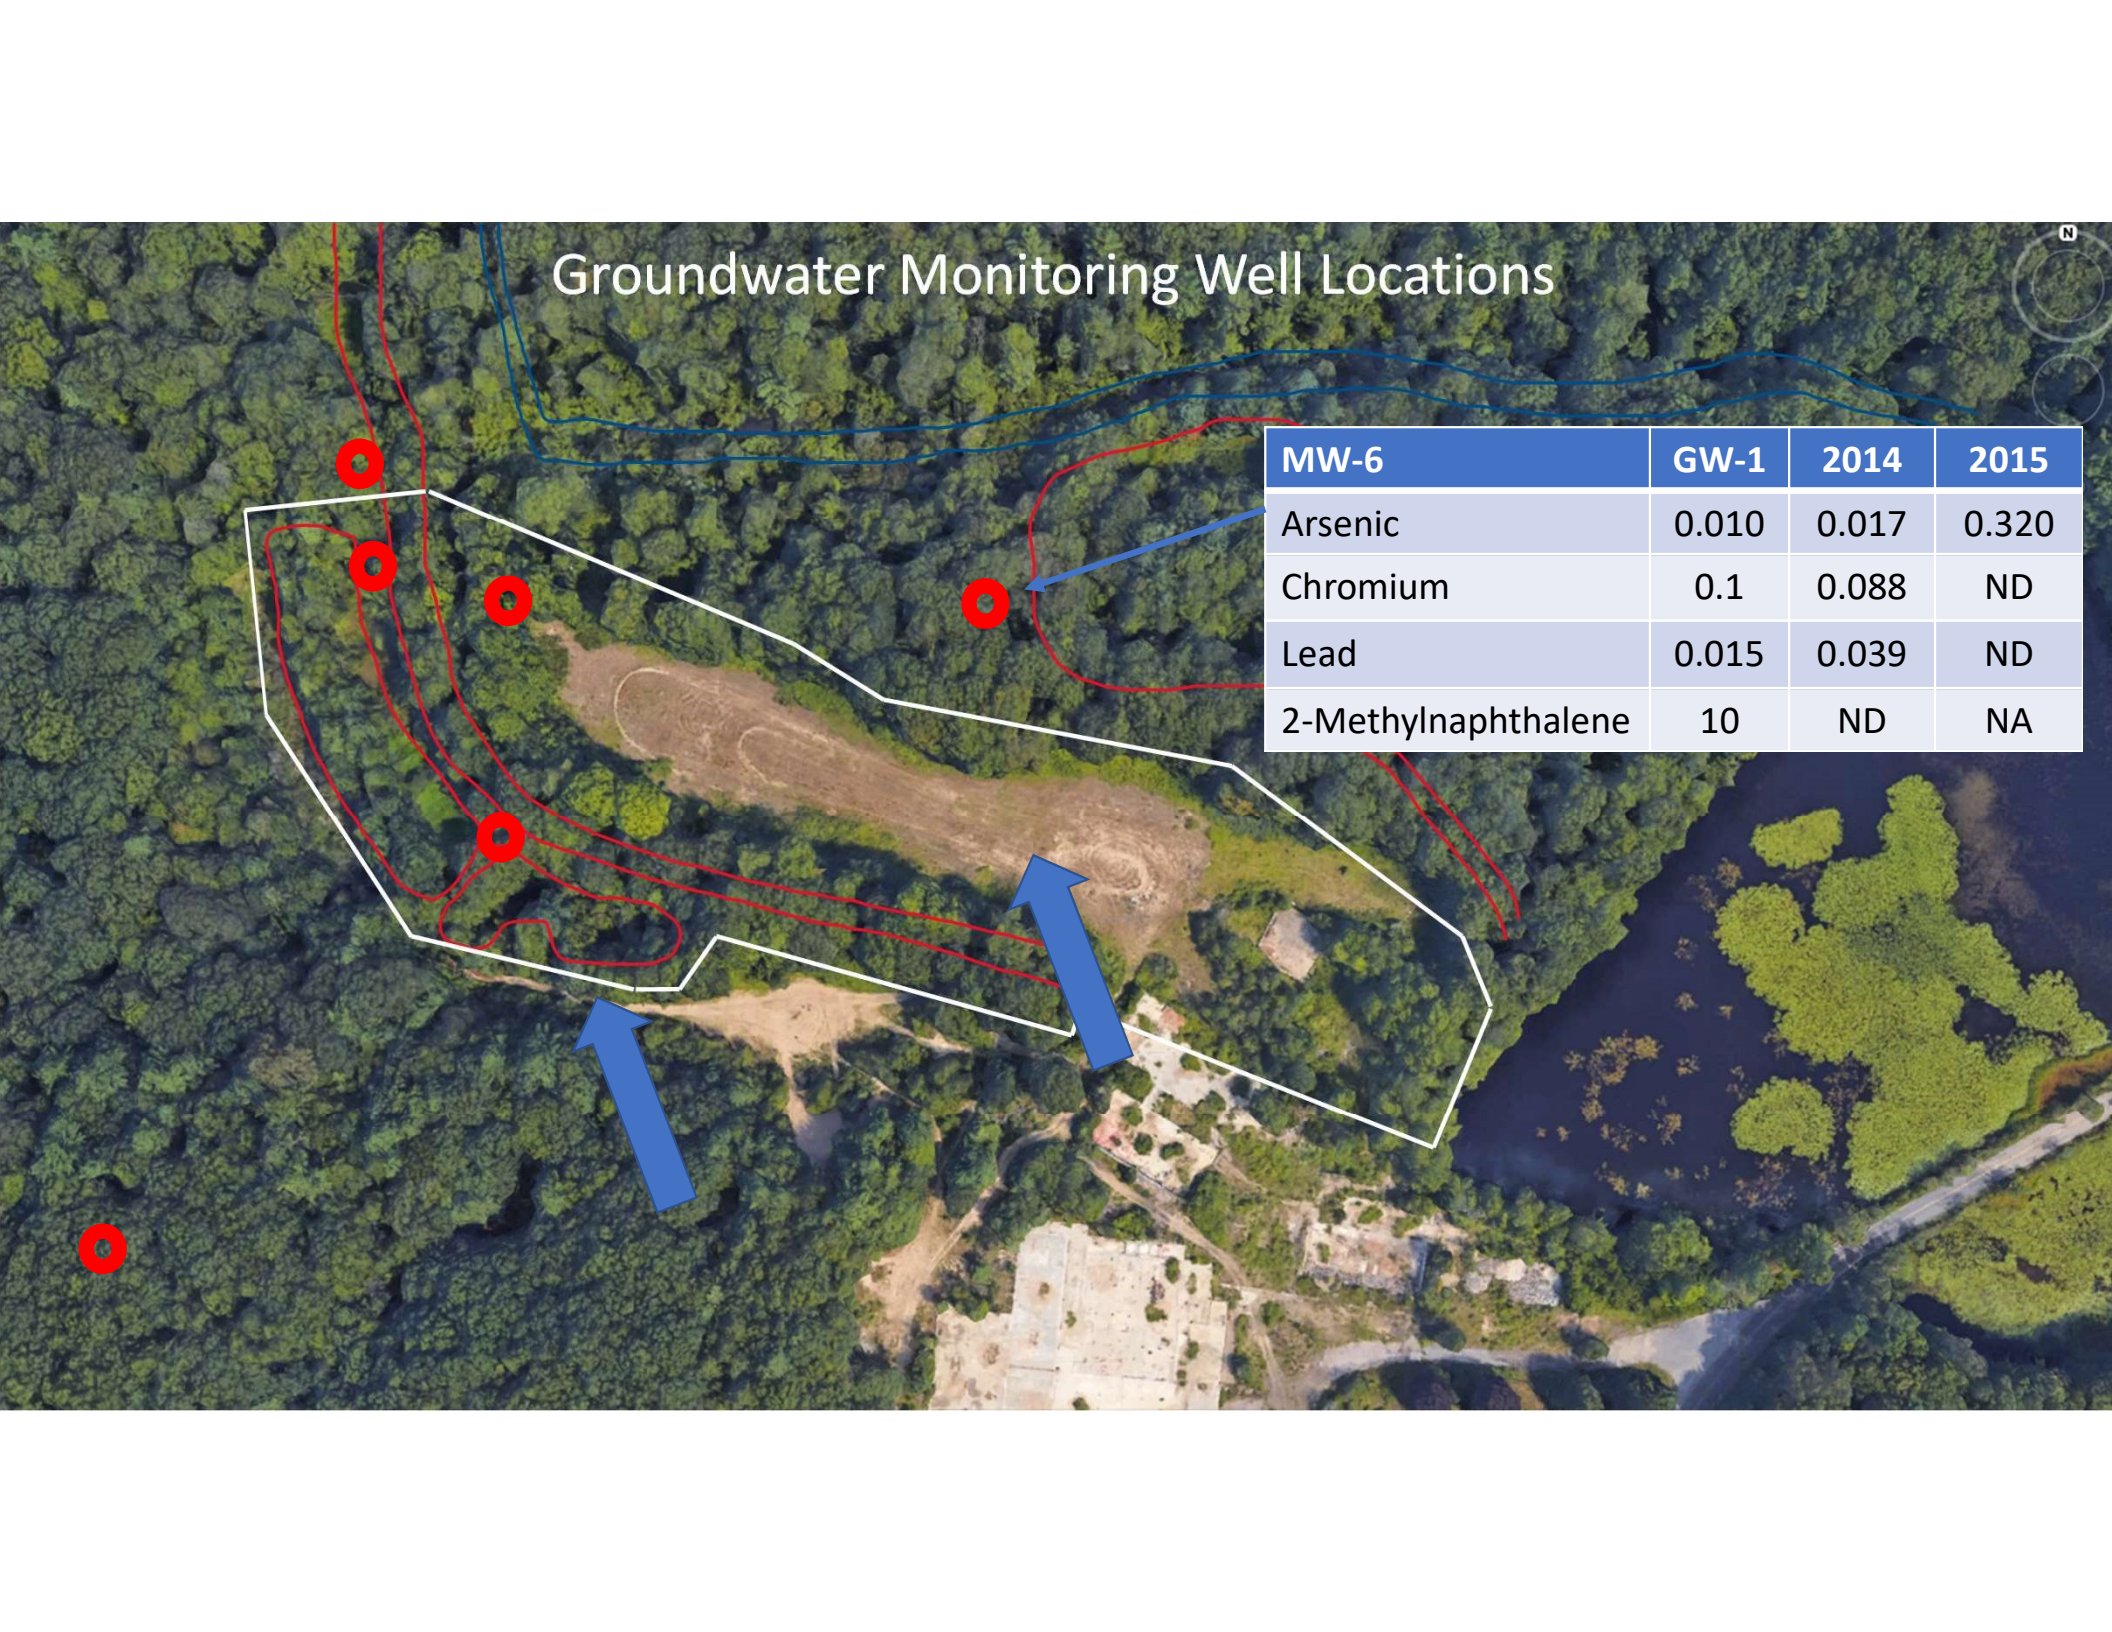
## Groundwater Monitoring Well Locations

MW-6	GW-1	2014	2015
Arsenic	0.010	0.017	0.320
Chromium	0.1	0.088	ND
Lead	0.015	0.039	ND
2-Methylnaphthalene	10	ND	NA

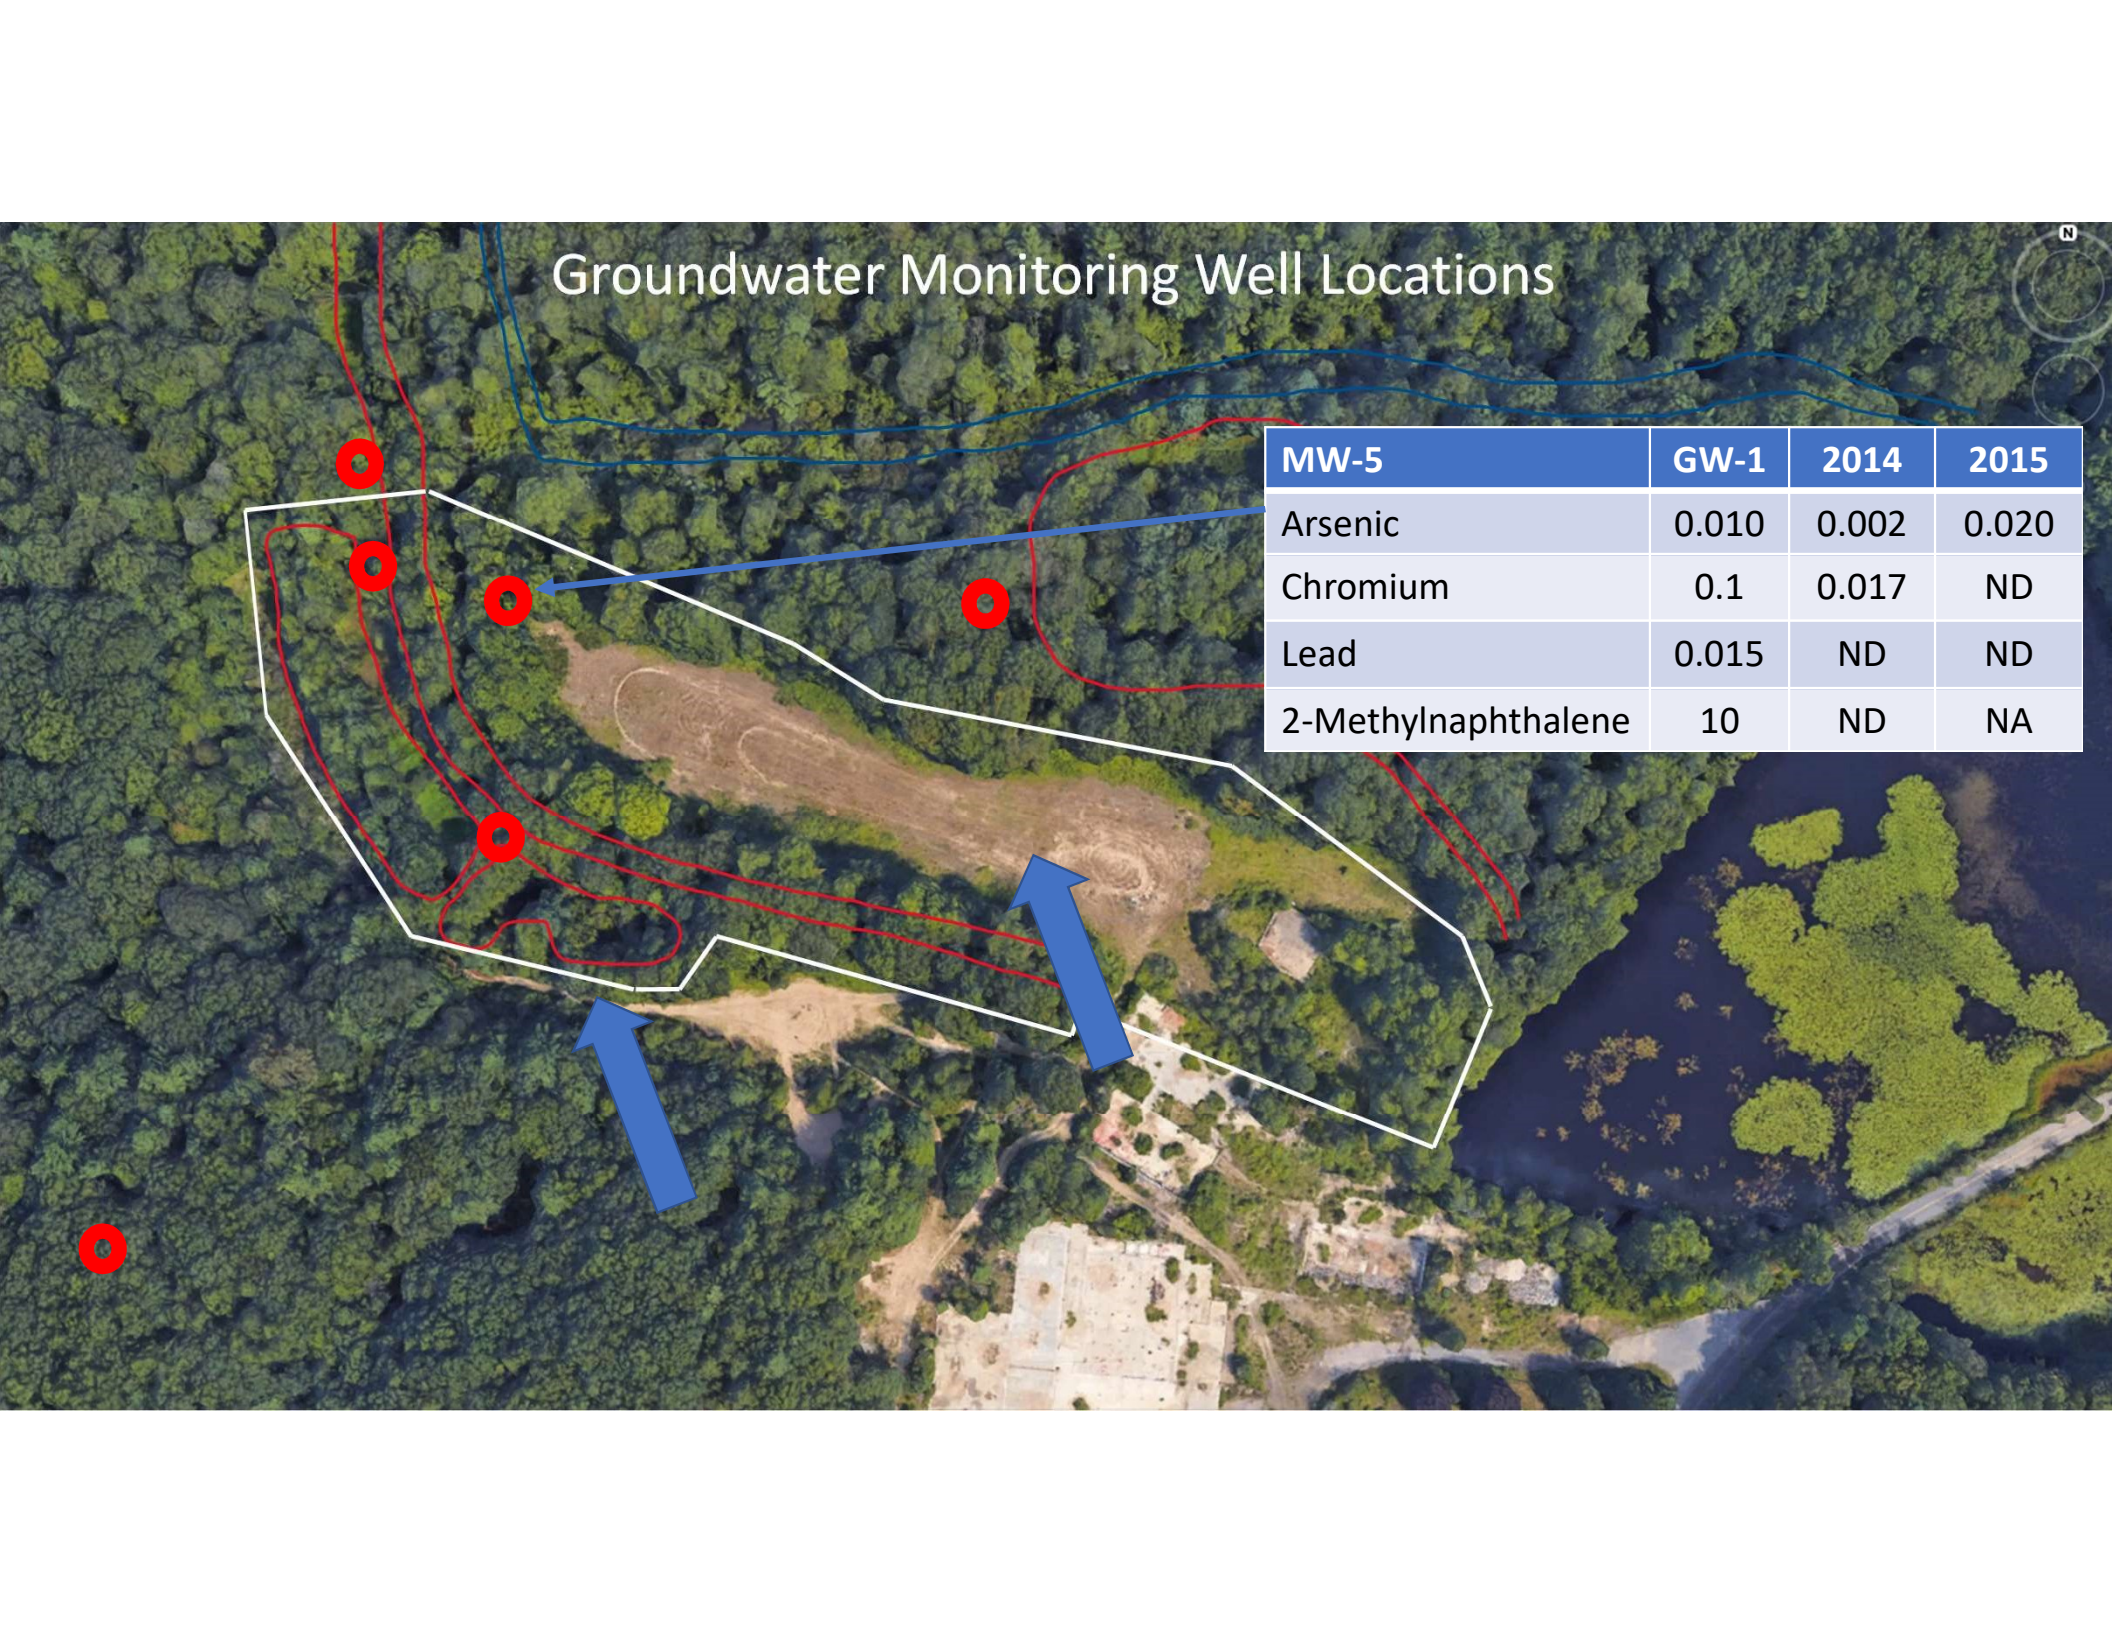
## Groundwater Monitoring Well Locations

MW-5	GW-1	2014	2015
Arsenic	0.010	0.002	0.020
Chromium	0.1	0.017	ND
Lead	0.015	ND	ND
2-Methylnaphthalene	10	ND	NA
